Town of Arlington

FINAL REPORT

ADA Self-Evaluation (as basis for Transition Plan)

Prepared by
Institute for Human Centered Design
December 15, 2014

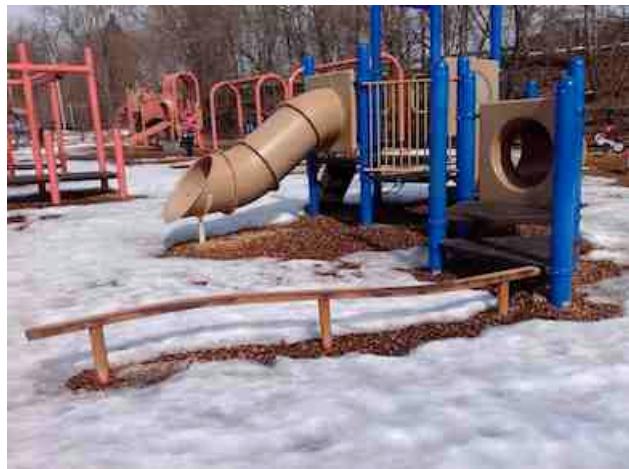
Photo 20

Play area loose fill surfacing materials do not maintain cross slopes not exceeding 1:48 (2.08%), and have uneven surfaces, with changes in level greater than 1/2 inch, and with openings greater than 1/2 inch diameter. A balancing ground play element extends into an otherwise clear circulation route and is not cane-detectable. (Photo 20)

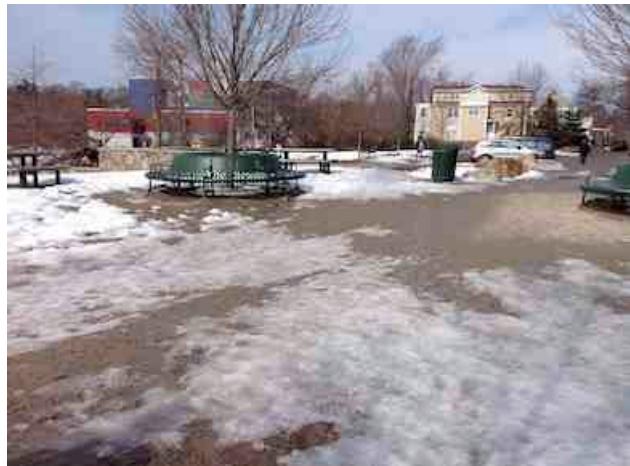
Photo 24

Seating areas, picnic tables, circle benches around a tree, trash receptacles and drinking fountains are provided through this linear facility, from north beach to south beach. These elements and amenities do not adjoin accessible routes and unobstructed firm, level ground spaces for integrated wheelchair seating are not yet included in seating and table arrangements. (Photo 24)

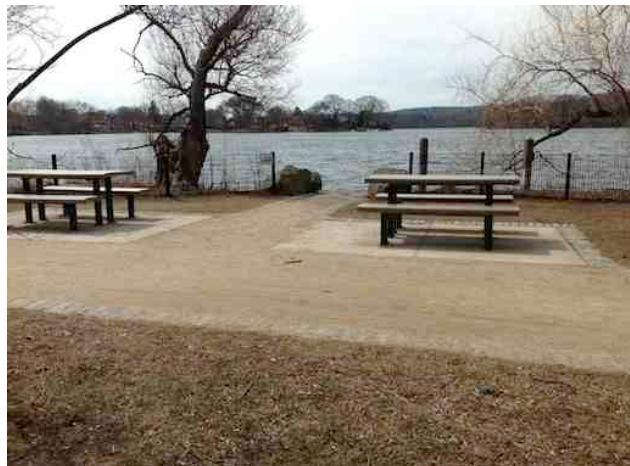
Photo 25

There are at least 7 picnic tables along the shoreline route from north to south. Tables are not connected to an accessible route. The ground surface under and around tables is uneven and slippery or, the level surface is not wide enough to accommodate an adjacent clear space of at least 30 inches by 48 inches along an accessible route. (Photo 25)

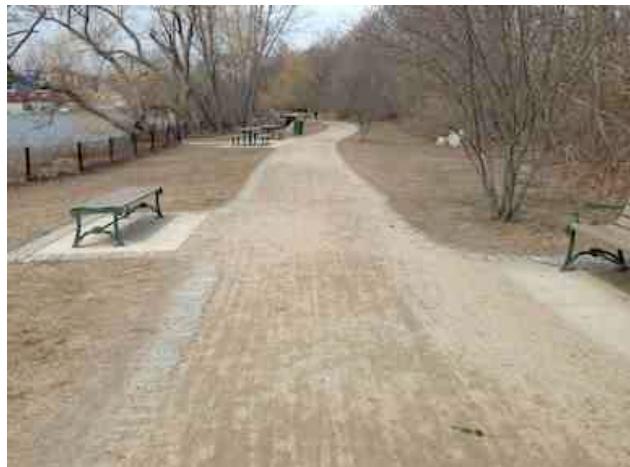
Photo 26

The benches are not connected by accessible route. The ground surface under and around benches is uneven and slippery. An adjacent clear space of at least 30 inches by 48 inches is not provided. At least one or 5% accessible benches at both North and South beach areas should be provided adjoining an accessible route. (Photo 26)

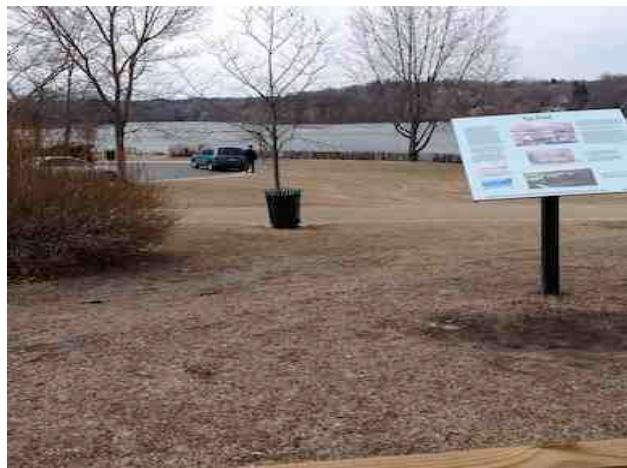
Photo 27

South Beach Sign installation is off the Bikeway path behind an erosion barrier. Sign is not accessible because ground surface to approach, view and read sign is not firm and slip-free. (Photo 27)

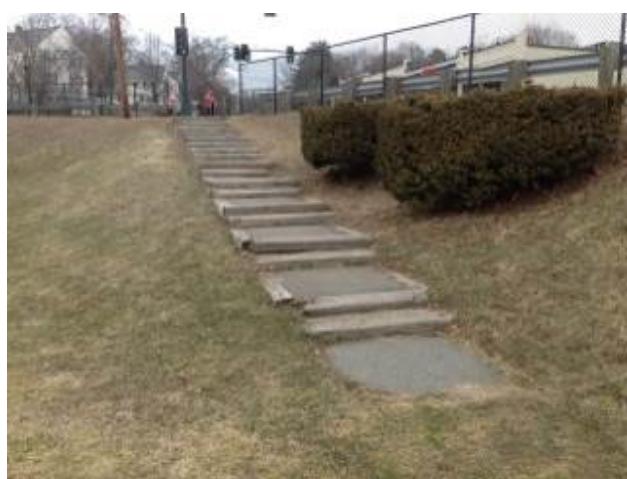
Photo 3

On Summer and Forest Street, stairways are in poor condition and are missing compliant railings on both sides. (Photos 3 and 4)

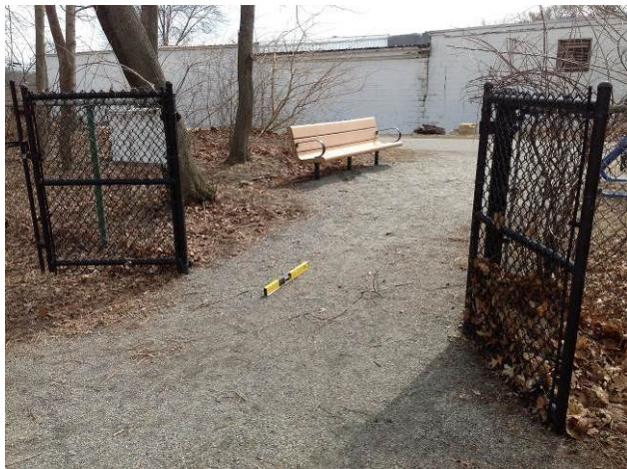
Photo 5

Along the Minuteman Commuter Bikeway, the asphalt walkway that leads to the multi-generational activity area has excessive running slopes (7%) and the asphalt walkway that leads to the parking adjacent to Ed Burns Arena is poorly maintained. (Photo 5)

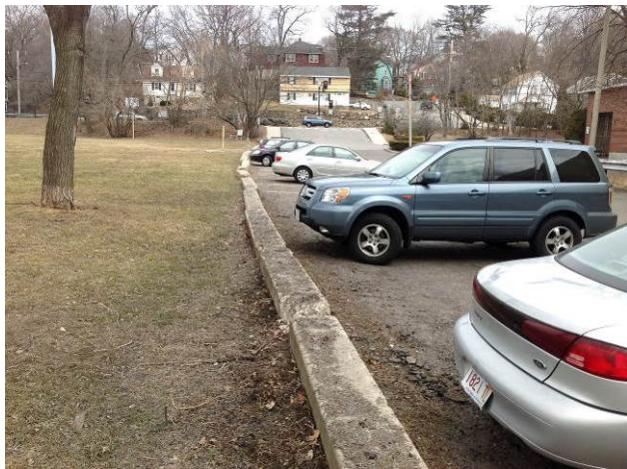
Photo 6

No accessible parking spaces serving this facility were identified in the marked parking spaces adjacent to Summer Street Park. (Photo 6)

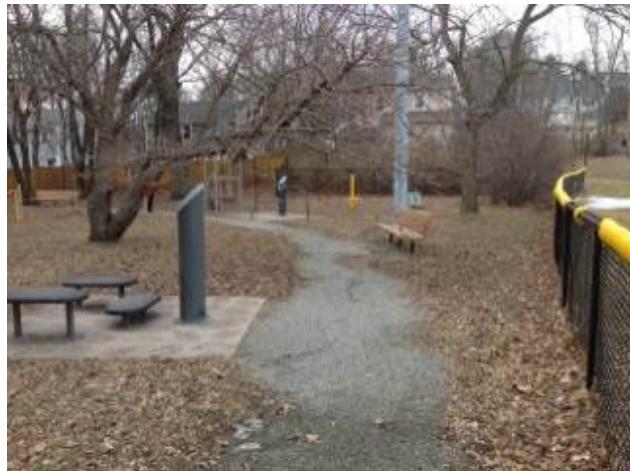
Photo 7

A stone walkway is provided between the parking lot adjacent to Ed Burns Arena and most features within the multi-generational activity area. In certain areas along the fitness course, tree canopies protrude into the circulation path, hanging less than 80 inches above the ground. This obstructs pedestrian vertical access from being continuous from one end of path to the other.

- 1 Interior Walkways:** Along the fitness course, trim trees so that branches over the path are no lower than 80" above the ground.
- 2 Field Playing Areas:** Install an accessible walkway between the point of entry and the baseball field and the grassy field used for field hockey.

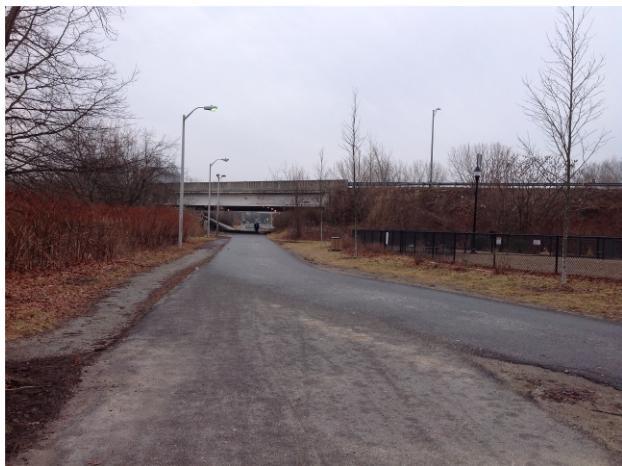
Photo 1

A stone path is provided between the parking lot and points of entry at the intersection of the parking lot and the Minuteman Commuter Bikeway. However, this path is in poor condition and is uneven, unstable, and steep at certain sections. (Photo 1)

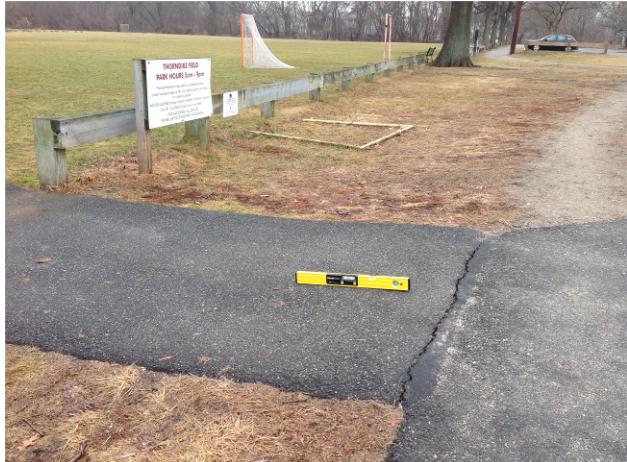
Photo 2

At the intersection of the parking lot and the Minuteman Commuter Bikeway, the asphalt walkway that leads to the grassy field has excessive running slopes (9.5% at the intersection with the bike path). (Photo 2)

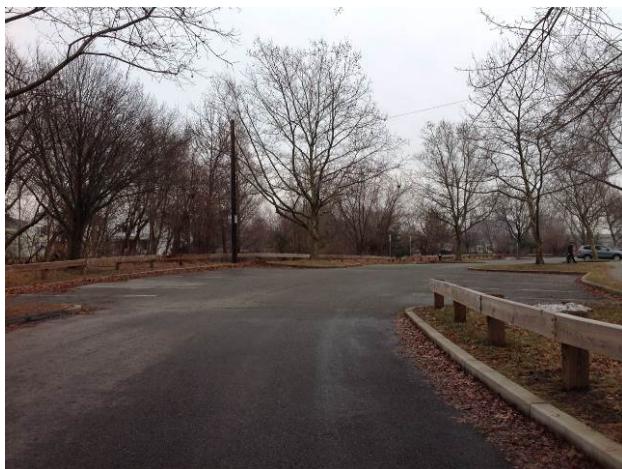
Photo 3

A parking lot with 67 parking spaces is located off of Margaret Street on the North edge of the site. Although three parking spaces are designated as accessible, no van-designated space is provided. Further, these parking spaces have access aisles that are integrated with curb ramps; however, they are located over 300 feet from the closest point of entry and 550 feet from closet point of entry at the dog park. (Photo 3)

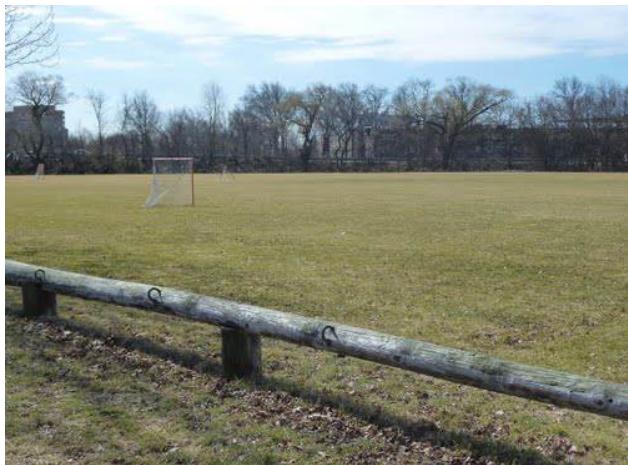
Photo 5

Although an asphalt walkway is provided between the Minuteman Commuter Bikeway and the edge of the grassy field, it does not extend to the boundary of the soccer and lacrosse fields. (Photos 5 and 6)

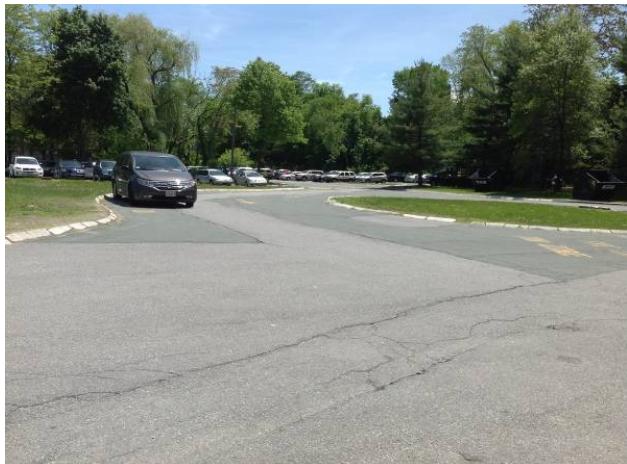
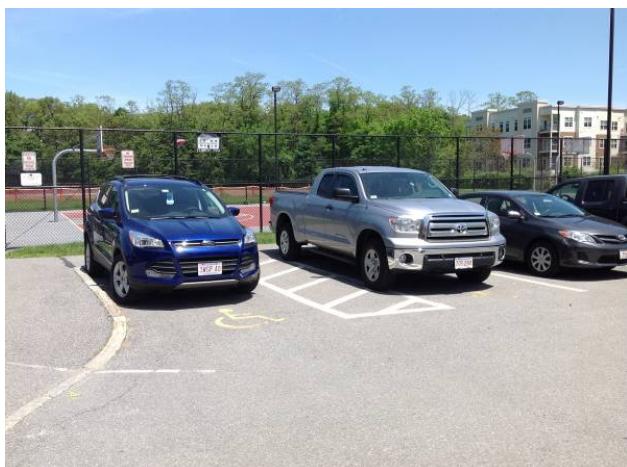
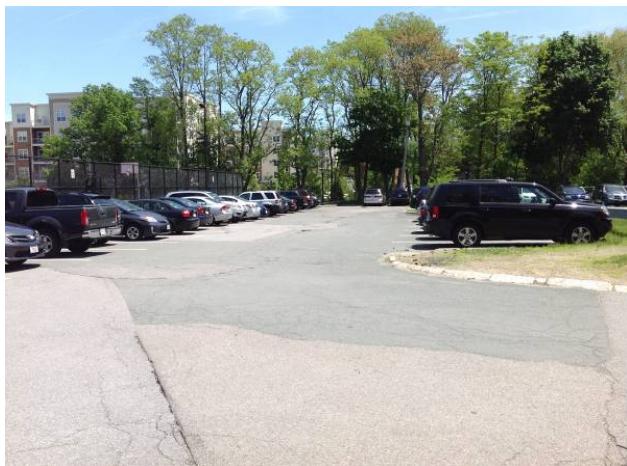
Public parking facility at Millbrook Drive has approximately 50 spaces, with two designated as accessible. The shared access aisle lacks the necessary width for van-accessible parking. (Photos 1, 2, 3)

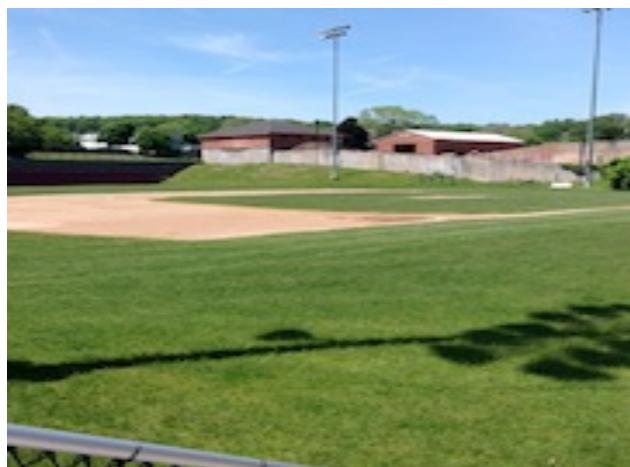
Photo 6

There is no accessible route to the boundary of the sports playing areas. (Photo 6)

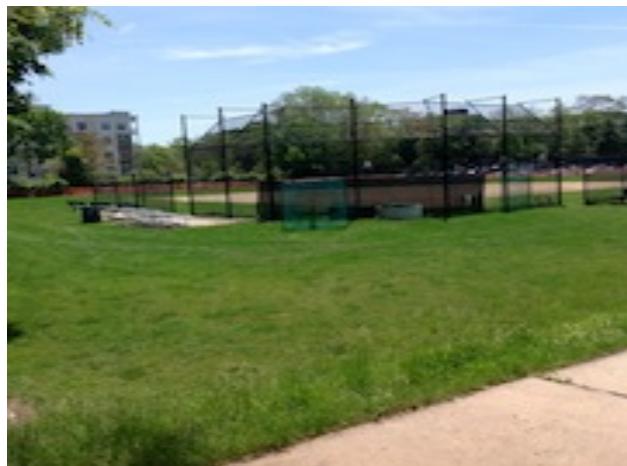
Photo 7

Smaller practice field south of east field does not have team seating area or bleacher area. There is no accessible route to the boundary of the sports playing areas for either of these fields. (Photo 7)

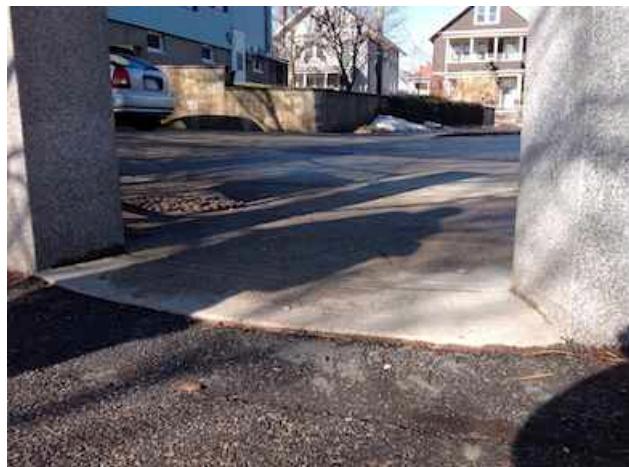
Photo 2

Curb ramps at Intersections near the Teel St. entrances do not connect with accessible sidewalks, have steep slopes and are missing level landings. New curb ramps at the Waldo Road/ Amsden intersection are incorrectly constructed as apex instead of perpendicular and lead users into road instead of along sidewalk route. (Photo 2)

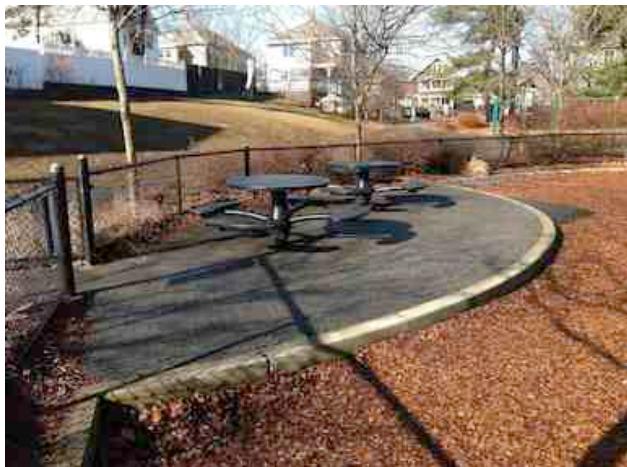
Photo 6

There are two gated entry points to the playground and sitting area (Photo 6) and, there is a gate to the Teel Street Basketball court entry point.

Gates are missing smooth surface or kickplate hardware. Teel St. gate to the basketball courts is not along an accessible route and ground surface is not firm, level and smooth.

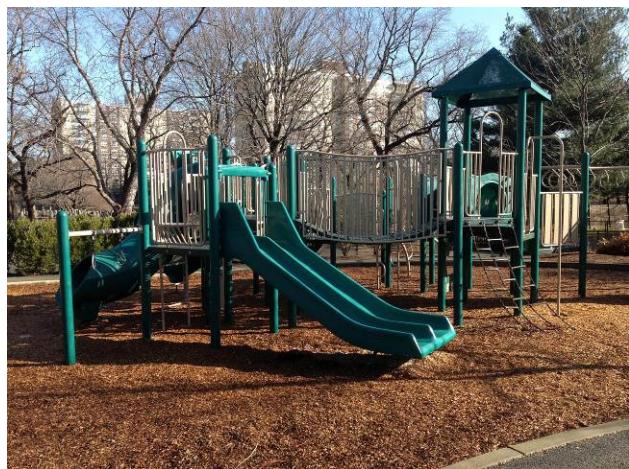
Photo 9

At least one accessible route is not provided within site perimeter to all entry/exit points of play areas, including court, swingsets and playground; and there is no accessible route provided to all entry/exit points of the ground play structures and elements within the play areas. (Photo 9)

Regrade and expand interior circulation paths to provide an accessible route that extends to the swingsets, all ground play elements within playground boundaries, seating areas, signage, and the basketball court.

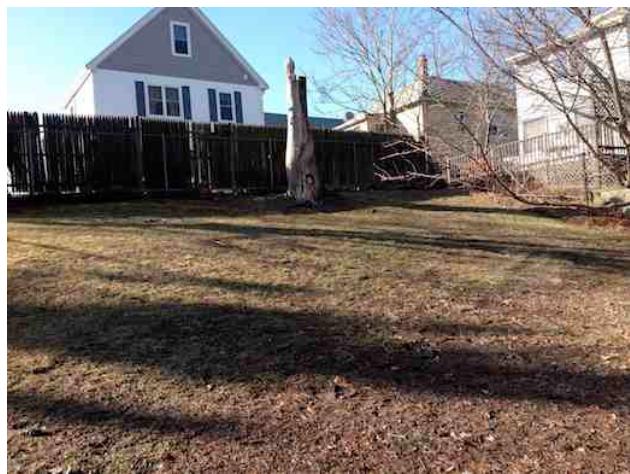
Photo 12

A public art tree sculpture sits on the west hill near the Waldo Road entrance. This art installation has the potential to be a special meeting and socializing area within this Park. If possible, a level-graded path with at least 36 inches width along the west perimeter of the park can be installed for all to approach and enjoy this unique feature. This path can connect with the Teel St. entryway. (Photo 12)

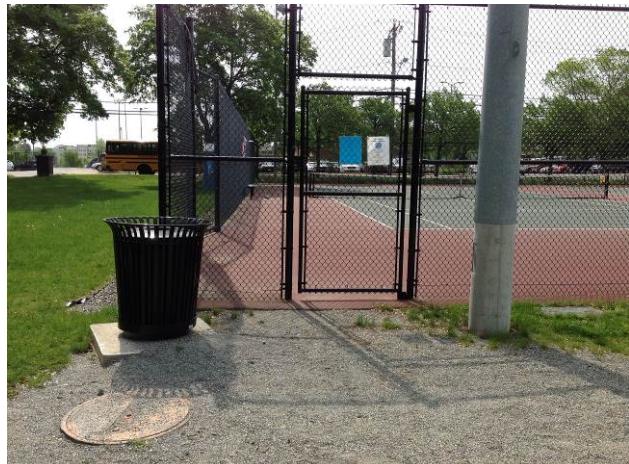
Photo 4

There are two gated entry points to each tennis courts. All gates are missing smooth surface or kickplate hardware. The surface of the two gates adjacent to the gravel walkway on the north edge of the courts is not firm, level and smooth. (Photo 4)

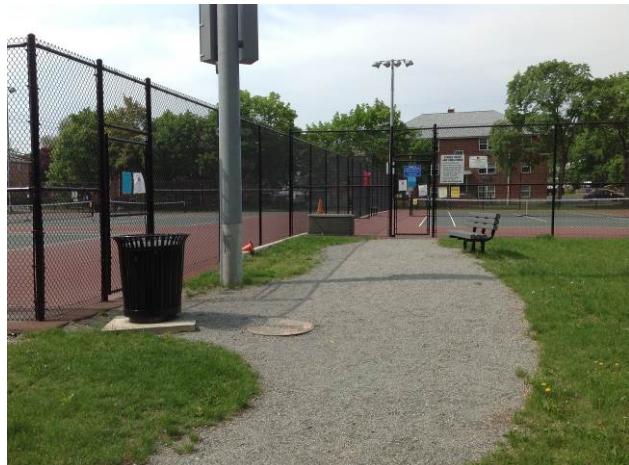
Photo 5

A gravel walkway is provided between the point of entry at the northeast point of the site and the north edge of the tennis courts. Walking surface is not consistently firm, stable or slip-resistant near the tennis courts. (Photo 5)

Repair/compact gravel walkway or replace it with asphalt walkway near the tennis courts (about 50 feet) and extend asphalt walkway from the tennis courts to climbing wall (about 150 feet).

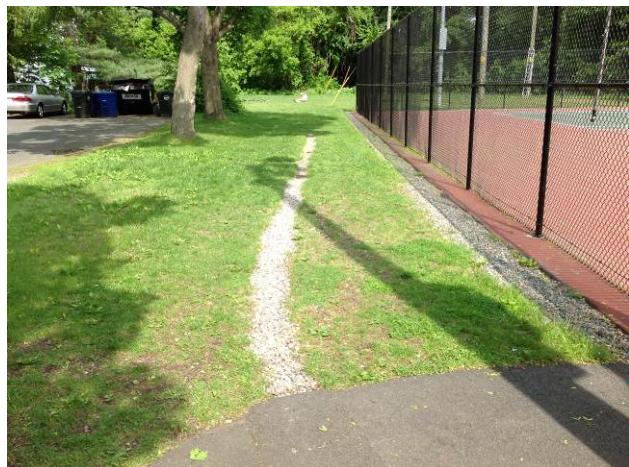
Photo 6

Along the south edge of the tennis courts, an asphalt walkway provides an accessible route between the street and the tennis courts. However, the walkway does not extend beyond the tennis courts and an accessible route is not provided to climbing wall on the west side of the site. (Photo 6)

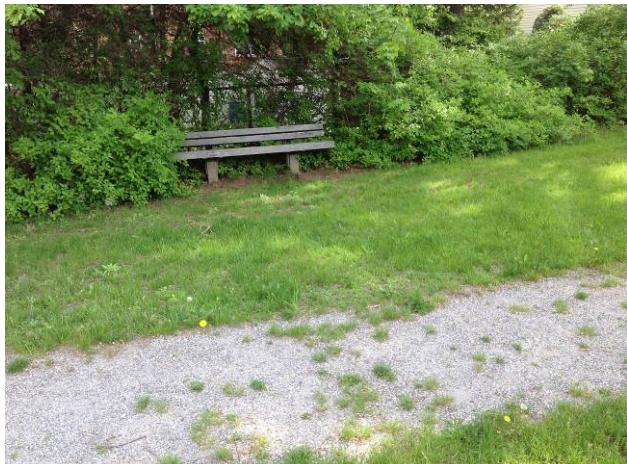
Photo 7

Two benches are provided along the gravel walkway on the north side of the tennis courts. One bench located along the north edge of the site is not inaccessible because it does not adjoin an accessible route. (Photo 7)

Neither bench has armrest nor do they offer integrated shoulder-to-shoulder clear ground space that is firm, level and slip-free for wheelchair seating.

Although not a requirement under the ADA, consider providing at least 50% with armrests, as benches are replaced (total of 2 benches).

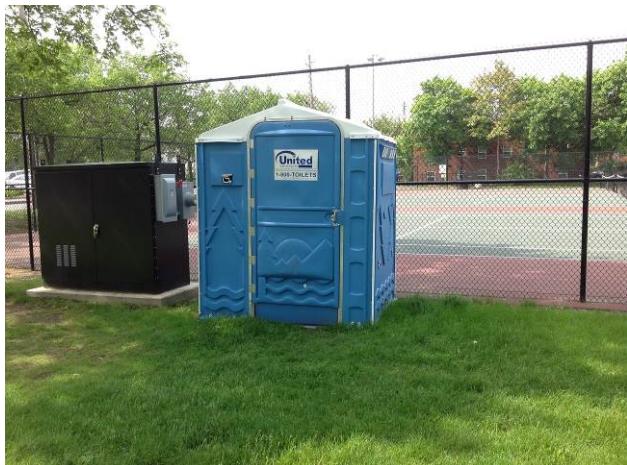
Photo 8

One portable toilet room is designated as accessible and is located along the north edge of the three tennis courts. However, this amenity is not accessible because it does not adjoin an accessible route. (Photo 8)
